Re: Offshore Fiber Optic Cables

**Exhibit A**  
**Selected Still Photographs**  
**from**  
**Hollywood 2-year Monitoring Video**  
**August 2001**

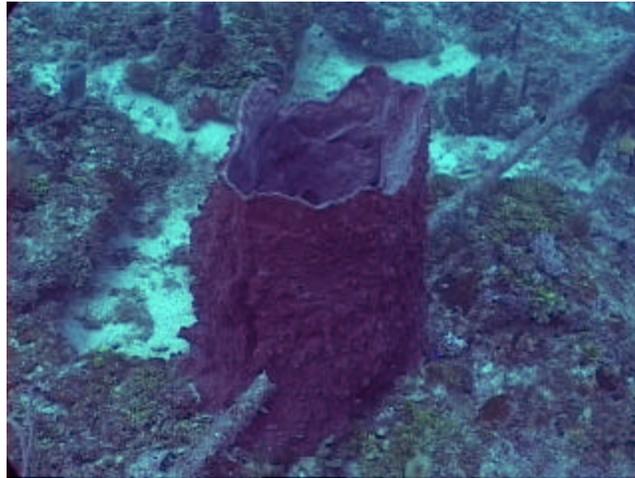
Figure 1. - Barrel sponge split by cable fusing together.

Some barrel sponges were impacted during the installation of the cables. We have been casually observing and photographing some of the injured sponges along the cable routes. The sponges heal along their edges and regrow. I will post on the PBS&J FTP site video clips of barrel sponges that were impacted by cable installation that have healed and will provide all with access methods for those clips. One sponge, in particular, that was split during installation has healed so that it appears that the cable was pulled through the sponge (see the attached photograph).

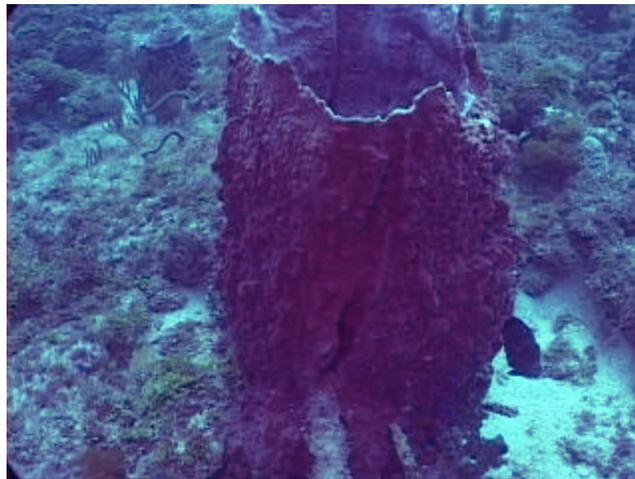
Figure 2. - Barrel sponge split by cable fusing together.

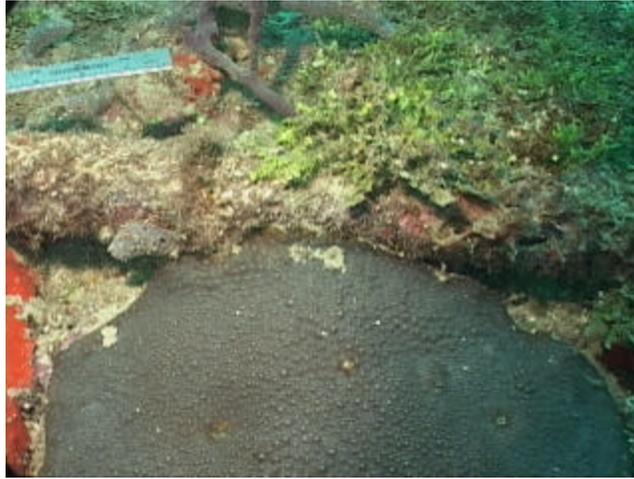
Figure 3. – Coral *Montastrea annularis* fusing onto and growing up the cable.

It is clear from the video that this particular coral, consistent with our general observations, had already begun to grow around and fuse itself to the cable. Again, I will try to post a video clip of a *Montastrea annularis* head that is growing and fusing with the cable (see attached photograph). One can see on the McAllister video, bits of coral broken off by the diver pulling the cable off of the coral. Unfortunately, the destructive action of the diver on the video, reopening a healed wound, has put the coral at increased risk of the algal invasion of which the voiceover warns.

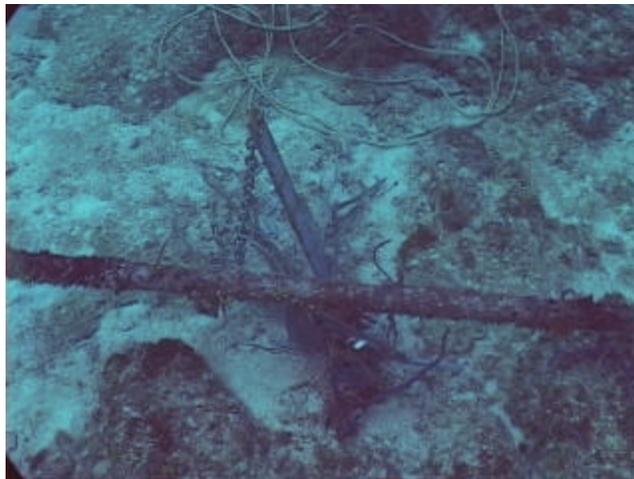
Figure 4. – Galvanized boat anchor found fouled on the cable.
